Faulty Flashing Above Lake Harriet Bay Window

The Addition of Flashing to the Edge of This Roof Saved This Minneapolis Homeowner Serious Money

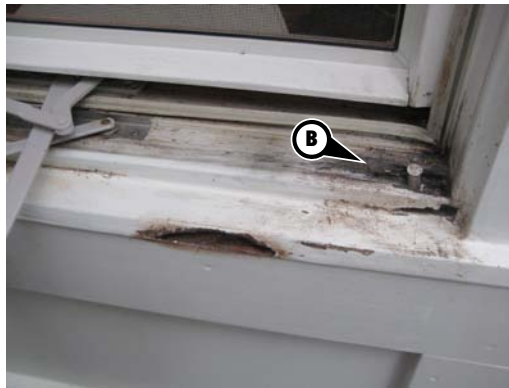
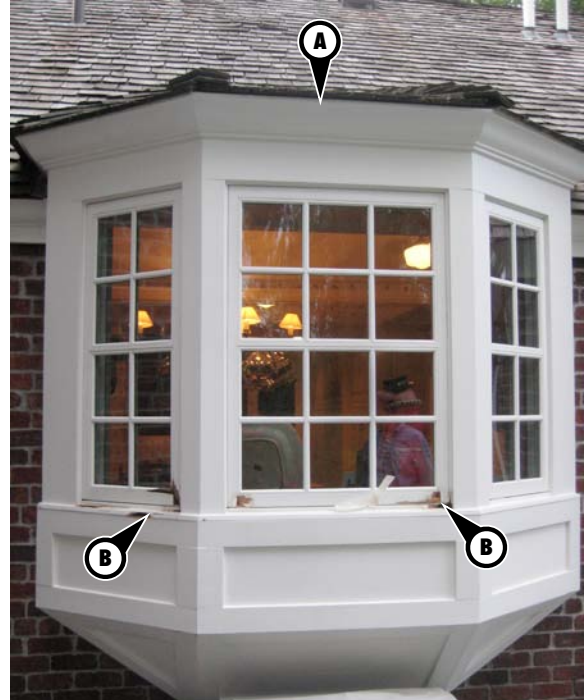
The original builder of this beautiful home near Lake Harriet in Minneapolis spared no expense when it came to quality in design and materials. But nobody is perfect. The original roofer installed the cedar shingles with an inadequate drip, or overhang, from the large crown moulding on the top of this bay window (A). As a result, water quietly leaked behind the crown and into the wall of the bay window, causing a fair amount of rot and damage to the wood casement windows (B).

In our opinion there was a smarter (and cheaper) way to fix this area that would last many, many years. First, to solve the issues related to the inadequate cedar roof projection we simply fabricated and installed a custom flashing under the first course of roofing and tar paper. Pow! Next, we dug out all of the soft wood and used an epoxy wood hardener to stabilize all of the areas affected by the water over time. Finally, we filled all the damaged areas with a two-part epoxy putty. After sanding it all down and painting, the place looked like new. It still does three years later.
