## What Does Hail Damage Look Like, Part Two

Minneapolis Hail Storms Leaves Clear Evidence Behind

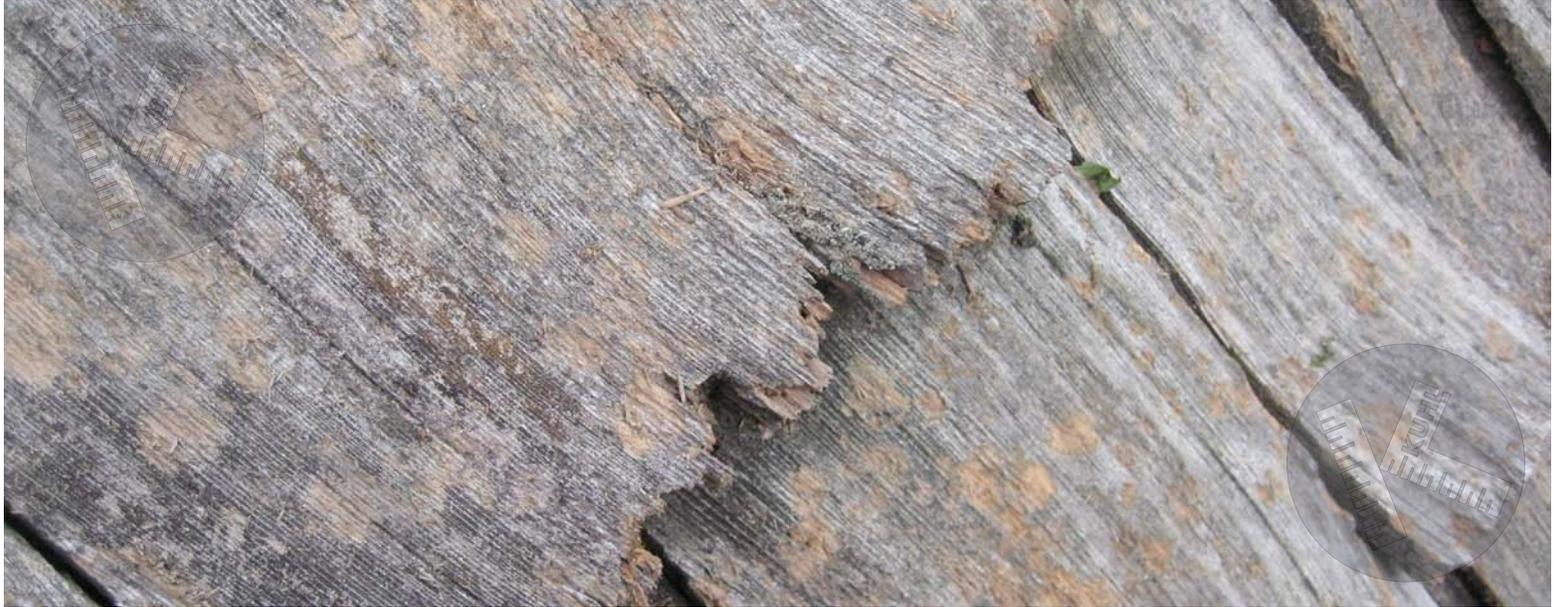
3/4" to 1" hail really whacked this poor roof on Lake of the Isles in Minneapolis. The material was 22 years old and was somewhat brittle prior to the hail storm. This enhanced the affect of every hail stone impact by allowing deeper penetration. Even if this roof were 5 years old at the time of this event it would have been damaged, just not to this extent. The damage seen on older cedar shake roofs, such as this one, are in direct proportion to the degree of existing embrittlement. For example, it was relatively easy to roll my thumb off the bottom edge of these shakes and produce 1/2" to 1" of crumbled cedar dust. Our clients had this roof insured through Chubb, which I have found to be the most generous and fair insurance companies to deal with in storm damage cases.

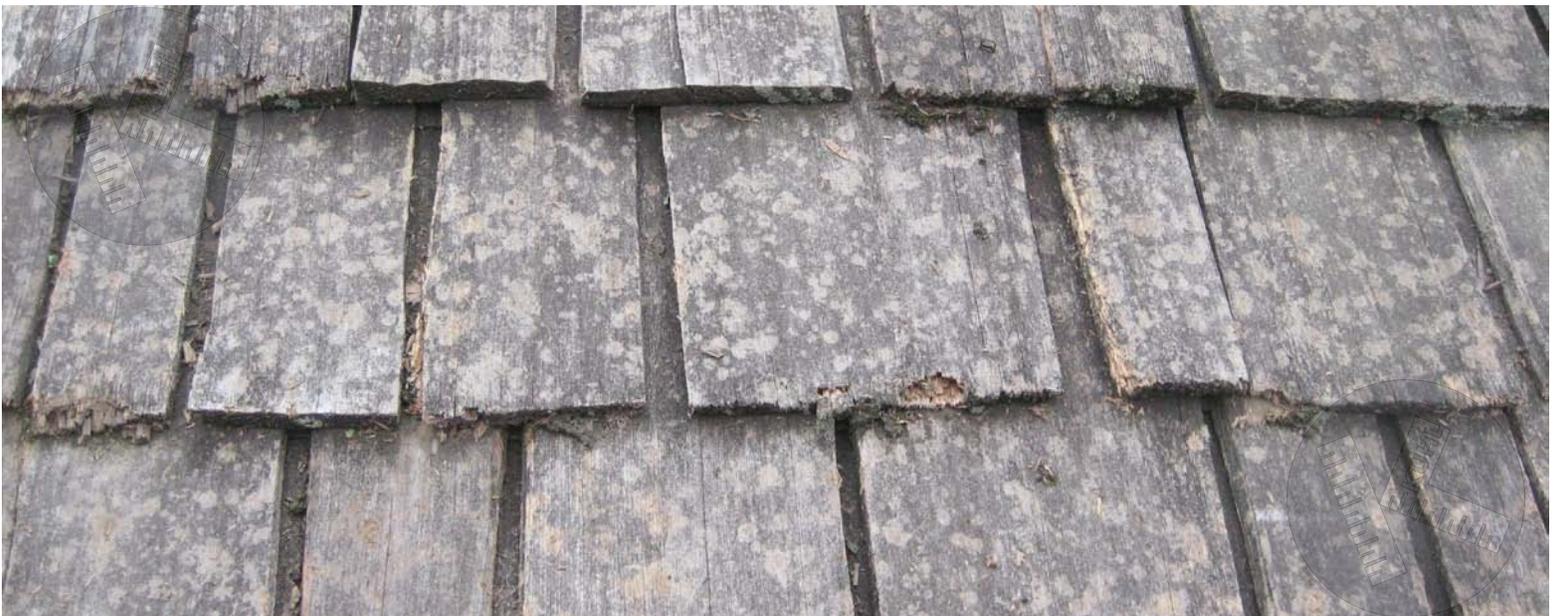
This is the same cedar shake roof on Lake of the Isles, Minneapolis. It's common to see different hail damage from one roof slope to the next. There are two reasons for this. First, hail storms normally throw hail from a dominant direction and the force of the hail impact is increased as the strike angle becomes more perpendicular (as opposed to glancing strikes). All of the south facing slopes can be trashed while the north facing areas are barely affected, for example. The second reason is that the orientation of a roof will affect how the wood ages significantly. Northern slopes tend to maintain hardness and integrity longer than south-facing slopes. Other factors such as tree coverage, roof pitch (steepness) and maintenance history factor in as well.
