Creativity Matters

Remodeling a bumpout window with a bad leak in Minnetonka

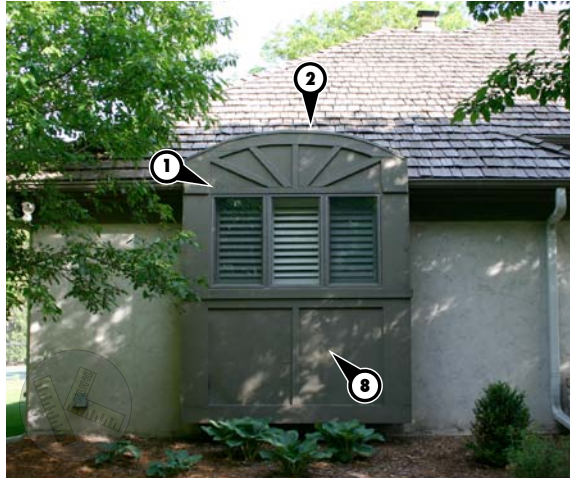
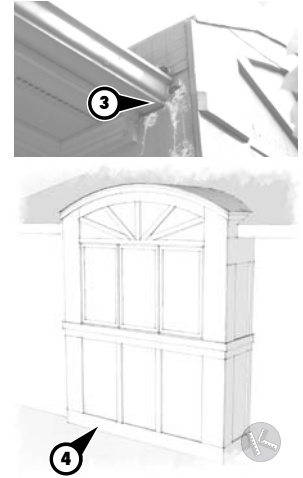
Imagine you have a window bumpout like the one here (right). The builder was running a little thin on his margin so he skimped on a few details. Now 13 years later, you have rotten siding, soggy millwork, and a roof that leaks. Now imagine that for the first time you looked at this feature on the front of your beautiful home and realized not only that it was rotten, but it was ugly too. You could find a roofer to fix the metal roof and then a carpenter to rebuild the bumpout. Or, you could call Kuhl to do it all and redesign a few key elements in the process to add a little more class to your home.

1. Missing z-flashing above window.
2. Thin gauge steel roof, rusted through and poorly installed.
3. Gutters terminated too close to wood resulting in big time rotting.
4. The overall design felt utilitarian and 'builder-grade'.
5. Rotten 1x2's arranged in a quasi-sunburst pattern
6. Steel roof installed short from fascia (= more rotting issues).
7. No kickout flashing (code required, and smart besides).
8. Totally rotten panels. And, how hard would it have been to add one more vertical stile to carry the lines of the window mullions through visually? Answer, not hard. It just requires some design experience.
