Good from afar (but far from good)

Cedar Roof Cleaning Franchise Perpetrates Another Bad Roof Renew Job in Orono

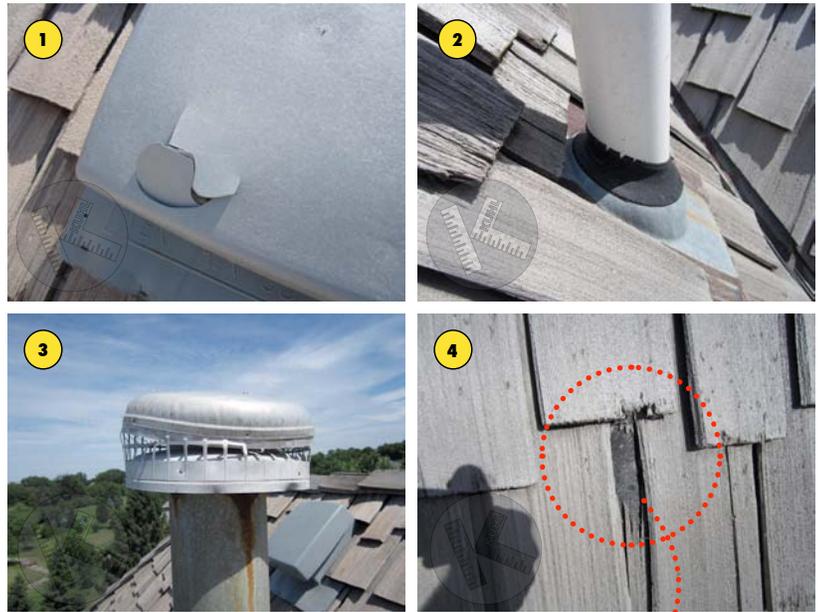
1. Cracked passive roof vent - needs replacement
2. Damaged boot flashing - needs to be replaced
3. Crushed Type-B flue cap - serious issue and potentially dangerous - may cause carbon monoxide to reach toxic levels in the home.
4. Open keyway between two shakes - this is an example of a shake that should have been replaced during the roof renewing process.

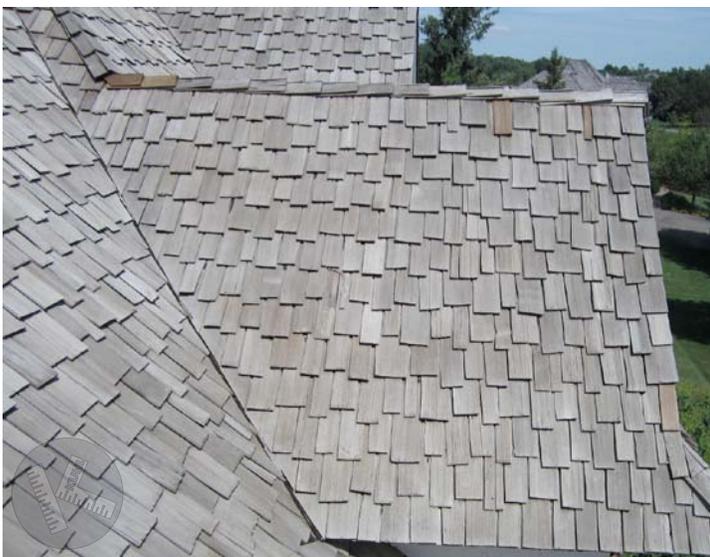
Hey, nice freshly washed & repaired roof

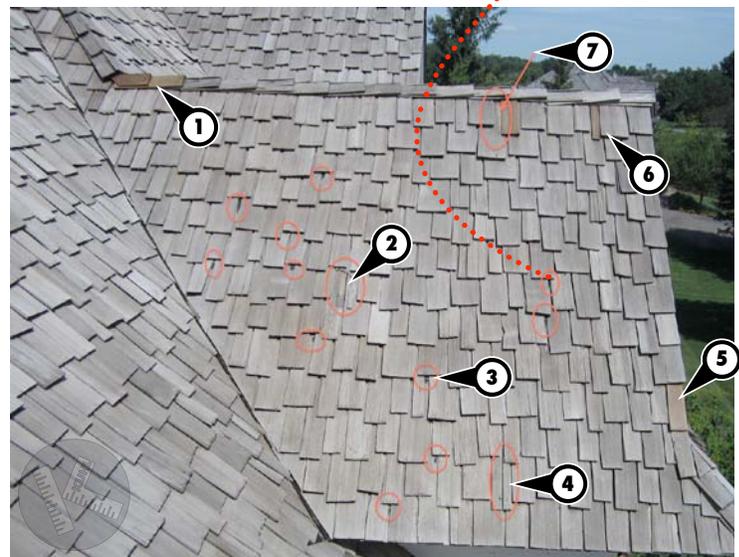
Or, I mean washed

List of issues left unaddressed after repairs were completed:

1. No Problems here. The ridge pieces were installed properly.
2. Missing shake - needs a replacement.
3. Open keyway - 1 of 11 such oversights on this roof area alone.
4. Crack in shake aligns with keyway in the course above.
5. Shake installed upside down.
6. Code requires minimum shake width of 2". This doesn't meet code.
7. Maximum keyway spacing allow by code has been exceeded.

Here is the skinny on cedar roof repairs. If you want to limit what you spend, make sure the person doing the repairs addresses the most severe areas first. You should have an understanding after the repairs have been performed as to what work was left undone, if any. This client needed another \$1,512 in repairs to complete the job.
