Ugly Chimneys In Eden Prairie

Clients Chimneys Were Leaking, But at Least They Were Super Ugly

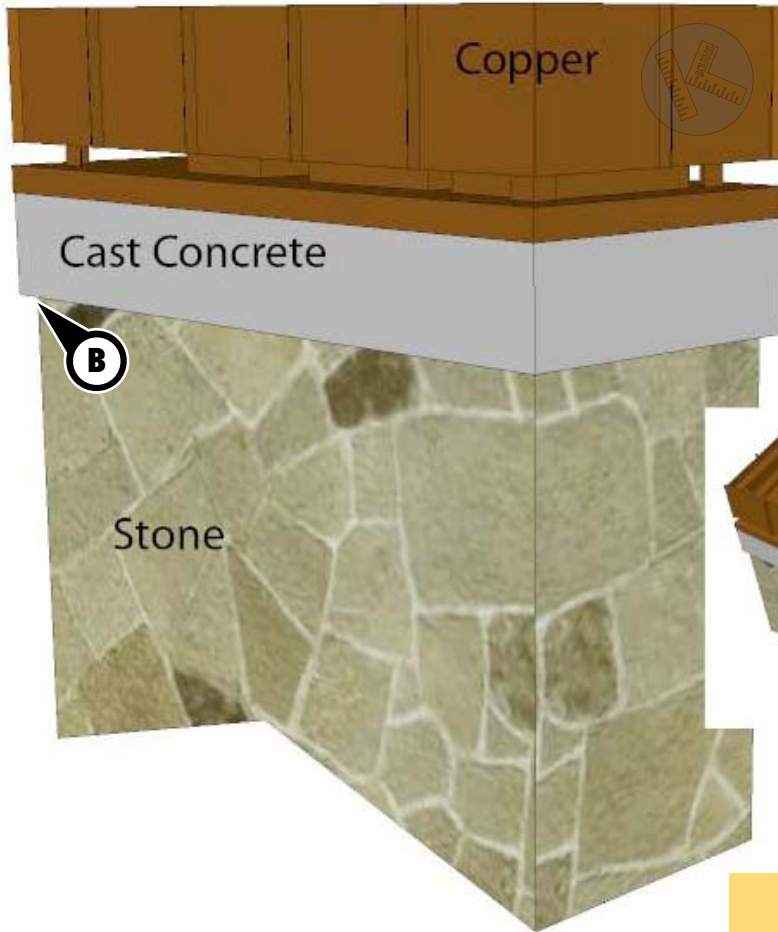
Our Eden Prairie homeowner needed a new cedar shake roof and two chimneys rebuilt. More than a simple chimney rebuild, these babies needed a redesign (thank you 1970's). The 12" thick lump of concrete originally installed on top just wasn't going to cut it anymore (A). Yes, they were not good looking, but worse, they allowed water to soak into the stone and into the home because there was not an adequate 'drip' (B), which is an overhang to encourage water to miss the walls of the chimney. Replacing the concrete washcaps alone would not have addressed the utilitarian character of these chimneys either. They needed some design (C) help and a team of craftsmen to pull it all together. Enter Kuhl.
