## What Does Hail Damage Look Like, Part One

### Minneapolis Hail Storms Leaves Clear Evidence Behind

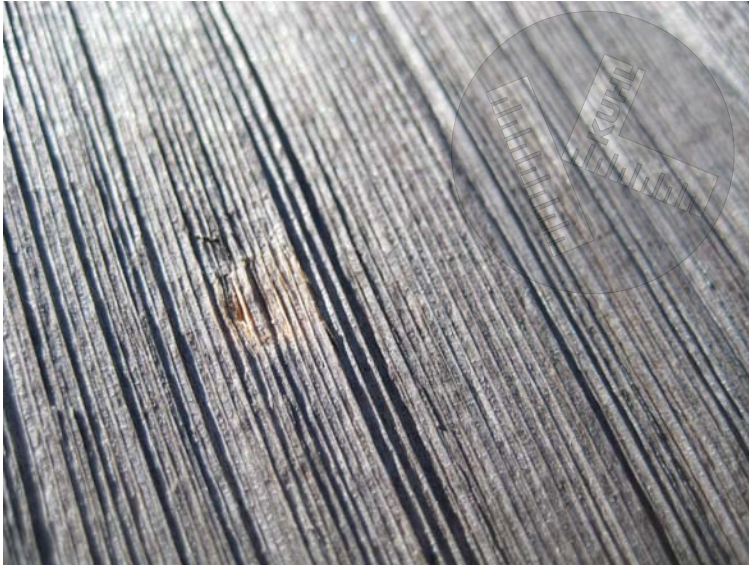
This is an impact mark from a .75" hail stone on a 3 year old medium hand-split cedar shake roof in Edina, Minnesota. Such hail frequently causes severe damage to cedar shake and shingle roofs. In this case the wood was resilient enough to escape with only a minor ding. Neighbors all around this home had their roofs replaced from the same hail storm. This roof sustained only cosmetic damage.

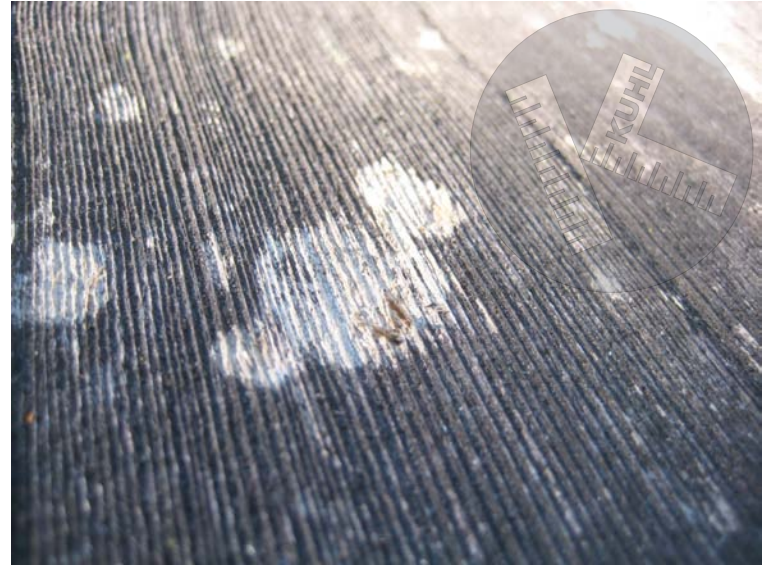
Here we see a 13 year old hand-split heavy cedar shake roof with heavy black mold and oxidation. The direction of the hail storm resulted in glancing blows rather than perpendicular strikes. The discoloration on the surface of the cedar shake has been removed by the impact of the hail stone but no functional damaged was done that will affect the integrity of the shake.

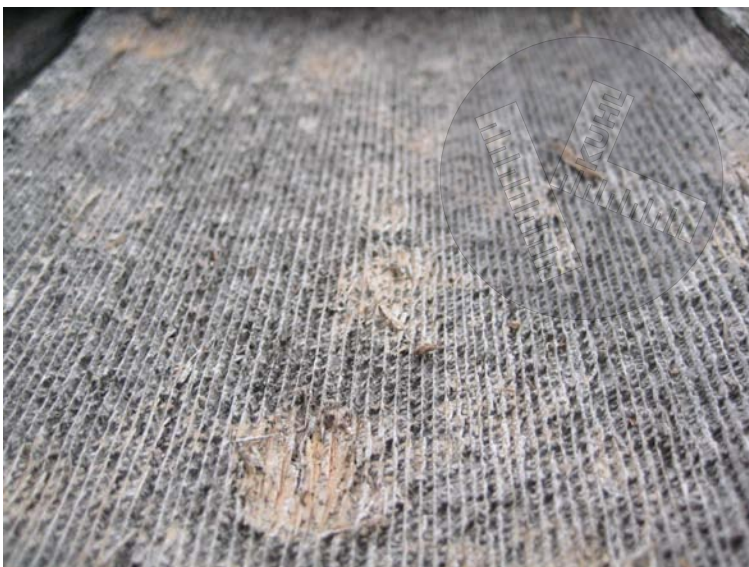
Hail storms in Minneapolis are all quite unique and localized. One neighborhood can be hit hard while the next one over barely gets hit at all. Pictured here is a 15 year old cedar shake roof in Plymouth, Minnesota after a severe hail storm. Not only was the hail .75" in diameter, it was very concentrated. While this particular cedar shake is more or less fine, there were many repairs needed on this roof in other areas.

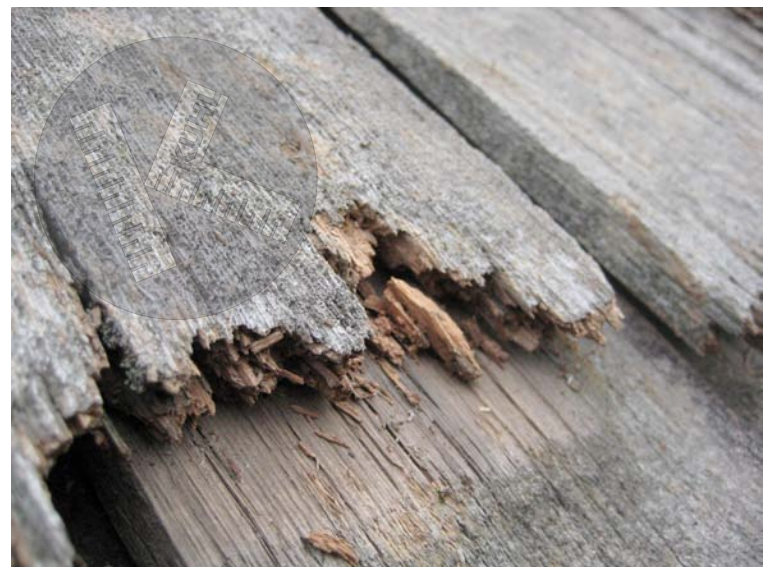
This cedar roof was 22 years old and was victim of a hail storm that went through Maple Grove a few years ago. The entire roof was littered with debris from the storm. There are a few interesting things to note: First notice how the cedar that was exposed as the result of the hail damage looks 'fresh', with orange coloring while the surrounding material is grey and weathered. Next, the hail damage is most severe on the butt edges of the shakes.
