Leaking Stucco Chimney Solution

Stucco Home in Eden Prairie Has Damage That Needed Fixing

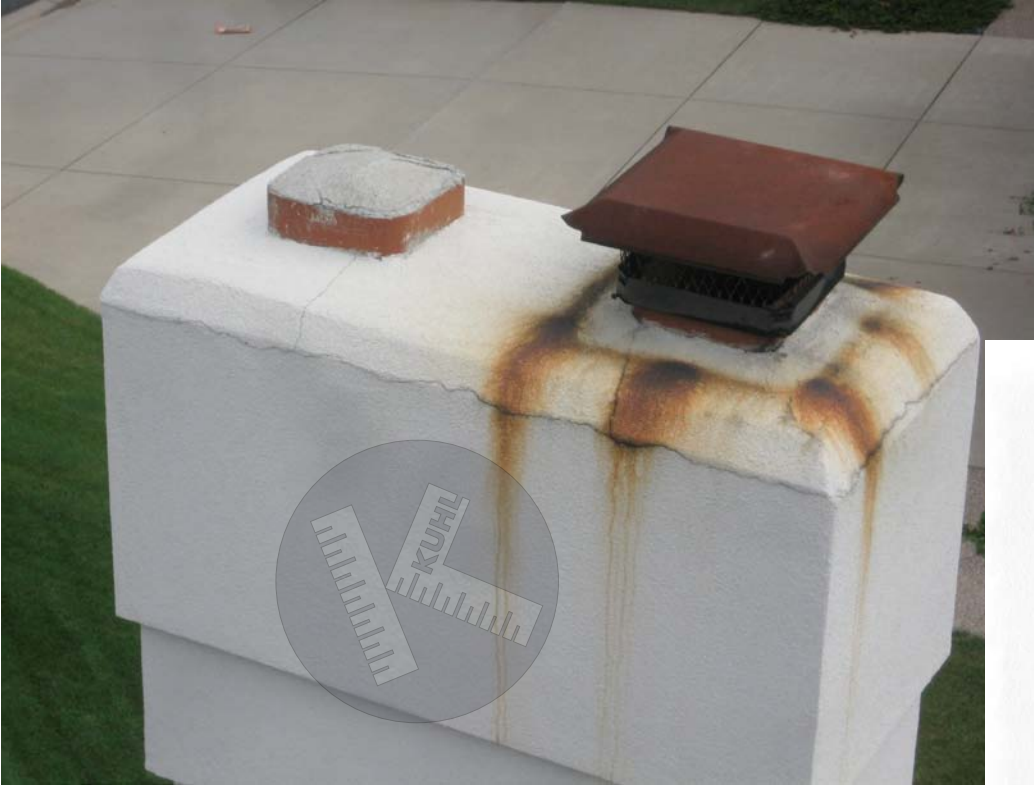
The cap of the original chimney had a sloped mortar core with a top coat of stucco (portland cement). Bad idea. We don't like stucco to be used on horizontal surfaces unless particular steps are taken. Water was leaking down into the chimney column and causing trouble below. Instead of rebuilding the upper portion of the chimney (big bucks) we advised our client to cover the existing cap with a custom copper chimney cap.

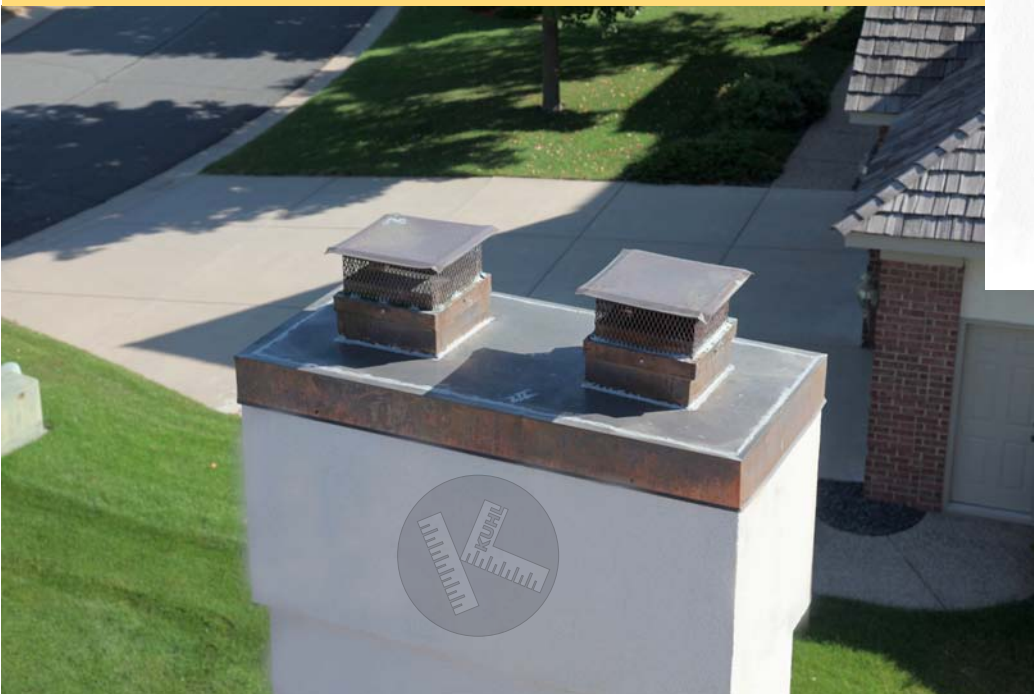
Many Kuhl solutions, such as this one, are based on a rendering produced specifically for each job. We would rather work out the details on the laptop than at your home as the work is underway. Plus, renderings allow us to have a conversation about design possibilities before any work begins.

The copper chimney cap we built for this home cost roughly \$1,200 to fabricate and install.
