?@%&#! Storm Chasers! One Edina Man's Story of Dealing with Storm Chasers and His Cedar Shake Roof

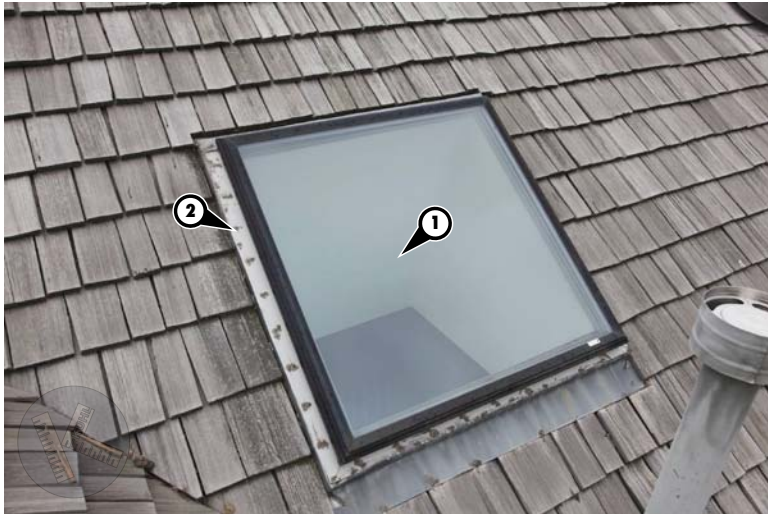
Jerry's roof was replaced by some storm chasers after a hail storm in 2006. His insurance company agreed to replace the skylight units (1) but refused to pay for the replacement of the curbs and curb flashing (2) because "they were not dented by the hail". So poor Jerry had new skylights installed on top of old, crusty curbs. It wasn't long before they started leaking. He chased the insurance company and the roofing company, who both successfully pointed the finger at the other. Sorry Jerry. You lose.

Would have, should have, could have. The fact was that Jerry was left holding the bag and someone had to fix these skylights. That's when he called us. We removed the skylights and bad curb flashings then fabricated a custom copper flashing to accommodate the existing roof flashing and the existing non-standard curbs. After we fabbed up the flashings it was a simple matter of soldering it all together and repairing the roof around each unit. Now years later, there have been no leaks.
