Creativity Matters

Remodeling a bumpout window with a bad leak in Minnetonka

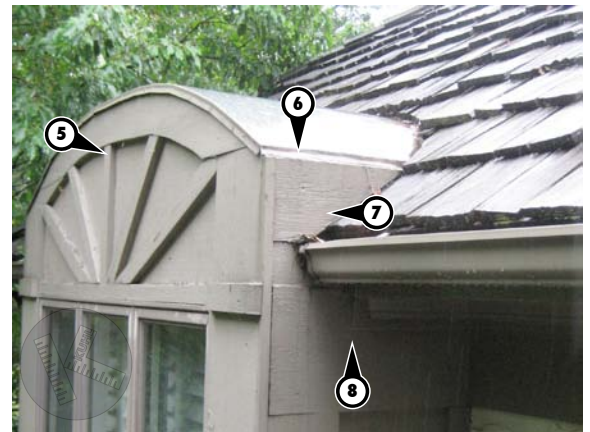
Things That Made Us Cringe Upon Inspection

1. Missing z-flashing above window.
2. Thin gauge steel roof, rusted through and poorly installed.
3. Gutters terminated too close to wood resulting in big time rotting.
4. The overall design felt utilitarian and 'builder-grade'.
5. Rotten 1x2's arranged in a quasi-sunburst pattern
6. Steel roof installed short from fascia (= more rotting issues).
7. No kickout flashing (code required, and smart besides).
8. Totally rotten panels. And, how hard would it have been to add one more vertical stile to carry the lines of the window mullions through visually? Answer, not hard. It just requires some design experience.

This was not a terribly complex project, but it could so easily have been handled wrong. Here are some of the things we did to rectify the problems with the existing design and construction:

1. Rot-proof Azek millwork. Smart.
2. New drip flashing under window.
3. Hey, look at the aligning stiles and mullions! Cost: \$1.09.
4. Rot-proof fiber cement panels.
5. Tudor detail to create subtle touch.
6. New standing seam copper roof.
7. Gutters cut back from millwork to prevent rot.
8. Kickout flashing installed to direct water away from sidewall and into gutter.
9. Cedar roof patched around new copper roof.
