Ugly Chimneys In Eden Prairie

Clients Chimneys Were Leaking, But at Least They Were Super Ugly

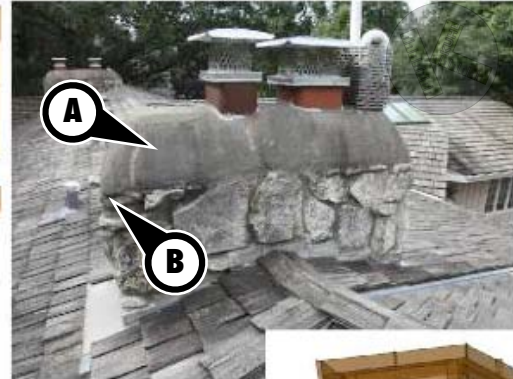
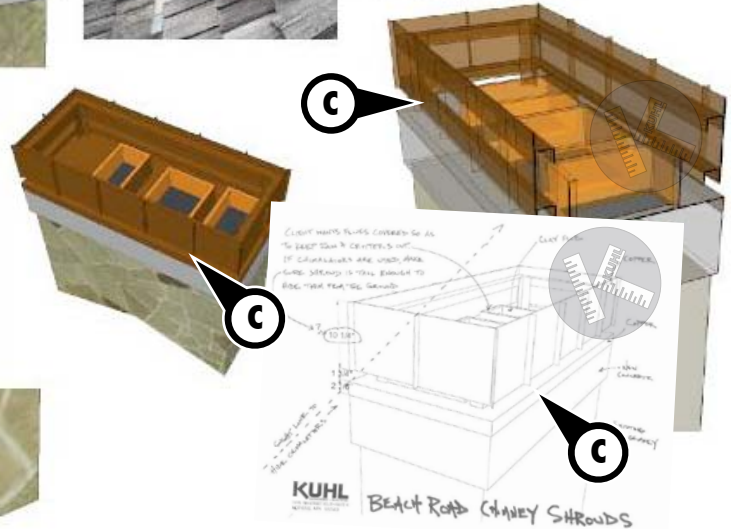
Our Eden Prairie homeowner needed a new cedar shake roof and two chimneys rebuilt. More than a simple chimney rebuild, these babies needed a redesign (thank you 1970's). The 12" thick lump of concrete originally installed on top just wasn't going to cut it anymore (A). Yes, they were not good looking, but worse, they allowed water to soak into the stone and into the home because there was not an adequate 'drip' (B), which is an overhang to encourage water to miss the walls of the chimney. Replacing the concrete washcaps alone would not have addressed the utilitarian character of these chimneys either. They needed some design (C) help and a team of craftsmen to pull it all together. Enter Kuhl.
